INSPECTION REPORT: GREENS CREEK MINE

Date of Inspection: Wednesday September 11, 2019
Date of Report: Tuesday October 1, 2019
USDA Forest Service Inspector: Richard Dudek

Ranger District: Admiralty National Monument, Juneau Ranger District
Weather Conditions: Sunny. Temperature: High 50's (°F).

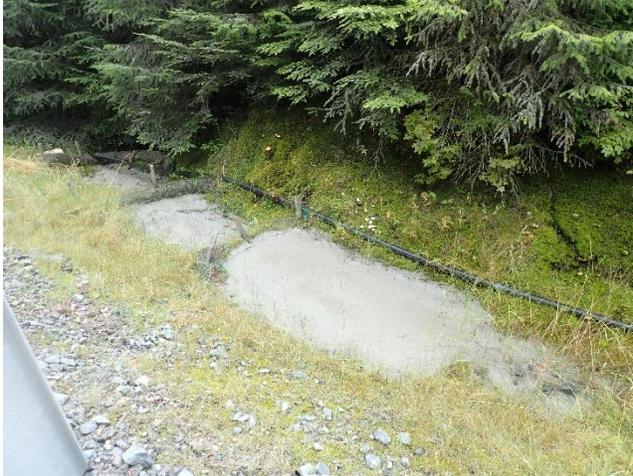
- **The 7.4 Mile B road Bridge downhill side BMPs for sediment controls require mucking (Photo 1).**

Photo 1. 7.4 Mile B road Bridge sediment sumps are at maximum capacity.

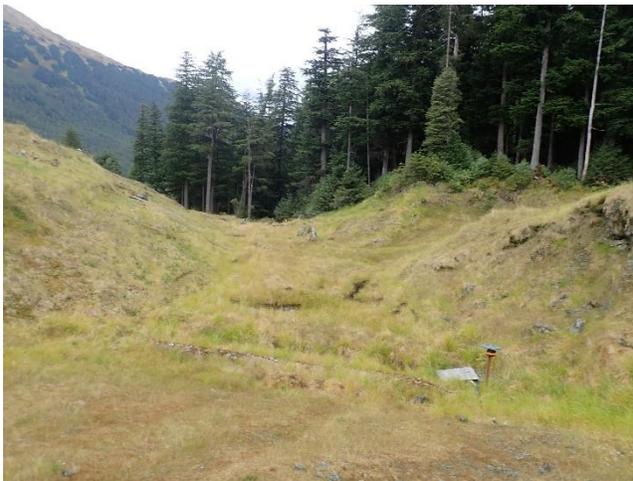
The pump and trench are operating as intended (Photo 2). The decommissioned underground fans that were staged at this location have been removed and will be shipped off site (Photo 3).

Photo 2. The 1350 trench and pump.

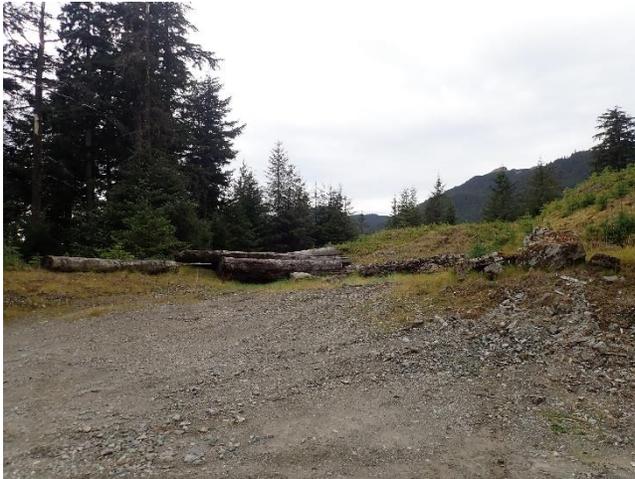
Photo 3. The 1350 area where the decommissioned fans were staged prior to being shipped off site.

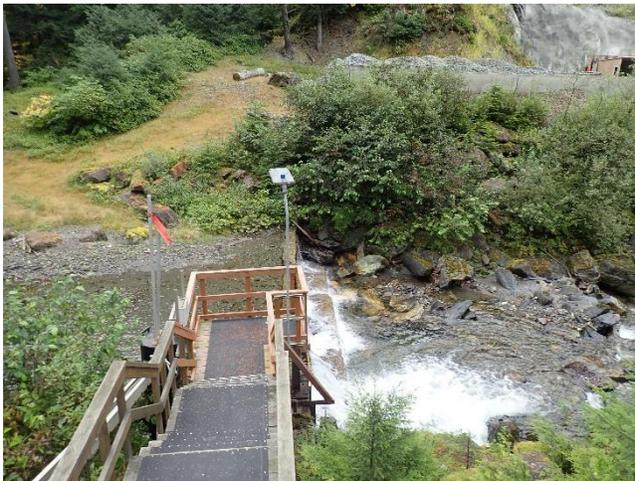
The recorded flow rate for Greens Creek (Photo 4) on 9/11/2019 was 10.8 cubic feet per second (cfs). The 920-area water withdrawal rate from Greens Creek was approximately 1.4-cfs.

Photo 4. The Greens Creek weir.

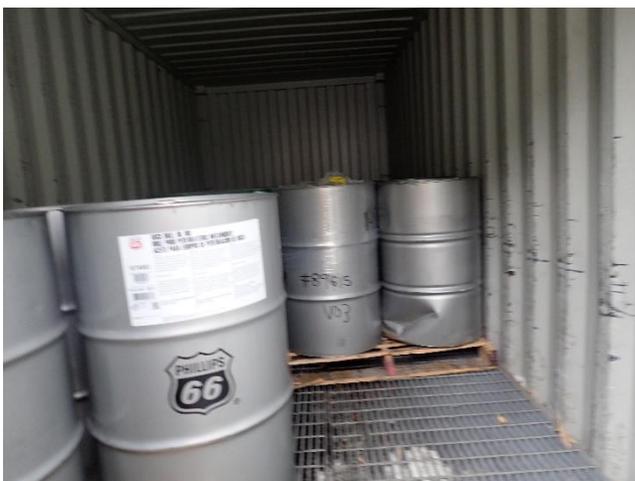
All petroleum/chemicals were properly stored within the appropriate secondary containment (Photo 5).

Photo 5. Petroleum products staged with secondary containment.

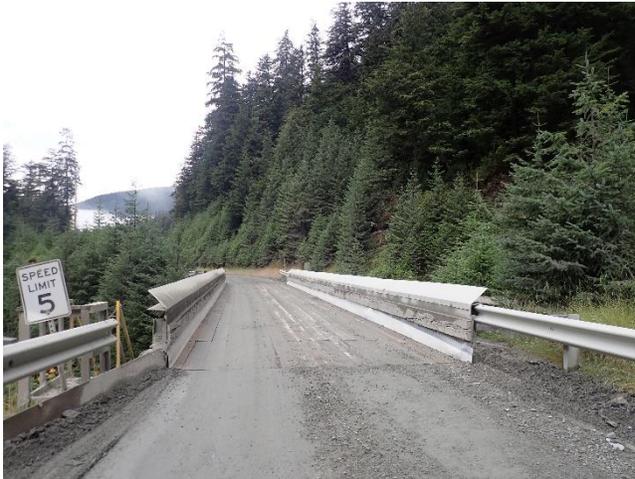
The bridge is being maintained by HGCMC Surface Operations (Photo 6). Surface Operations recently re-decked and installed a new liner for the bridge (Photo 7).

Photo 6. 7.4 Mile B road Bridge (Falls Creek Bridge).

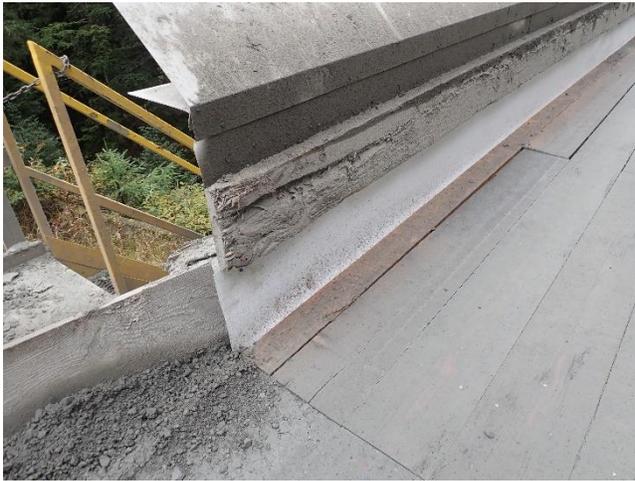
Photo 7. The sides of the new liner were tacked to the bridge.

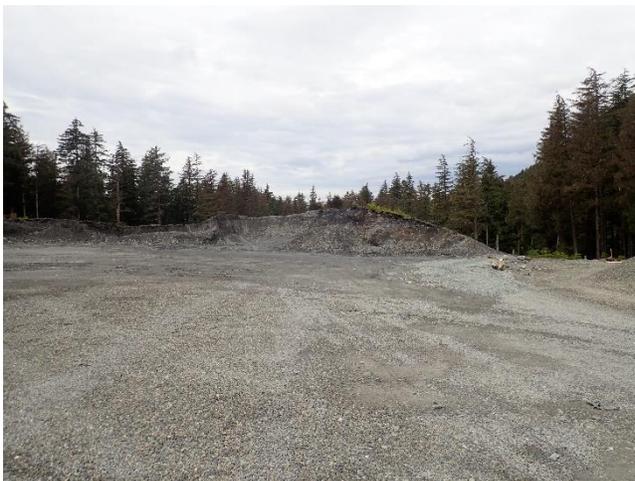
Photo 8. Site E (4.7 Mile B road)

HGCMC personnel continue to remove waste rock from this location for disposal in the TDF (Photo 8).

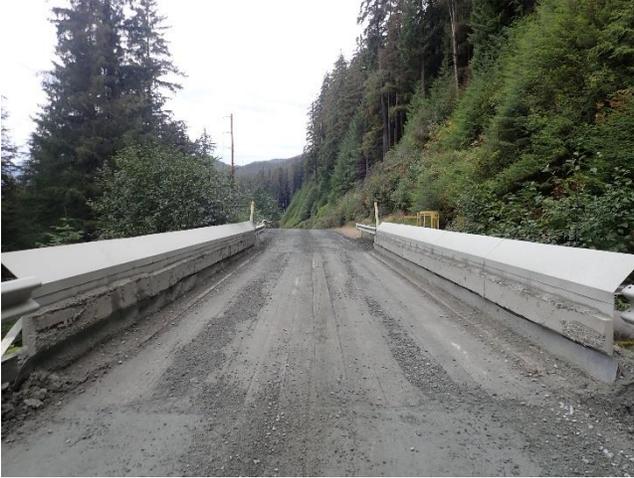
The bridge is being maintained by HGCMC Surface Operations (Photo 9). Surface Operations plan on re-decking and installing a new liner for the bridge by mid-October.

Photo 9. 3.4 Mile B road Bridge (Falls Creek Bridge).

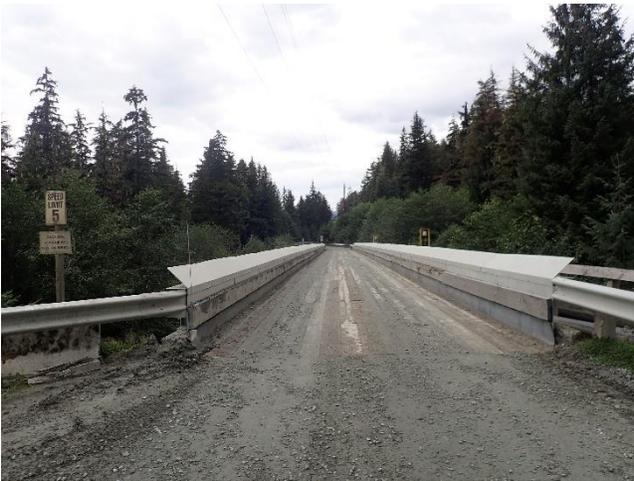
HGCMC Surface Operations are maintaining the bridge (Photo 10), and the structural BMPs located on the uphill side abutment are functioning as intended (Photo 11). Surface Operations will be installing a new liner and re-decking the bridge in the coming weeks.

Photo 10. 3.0 Mile B road Bridge (Zinc Creek Bridge).

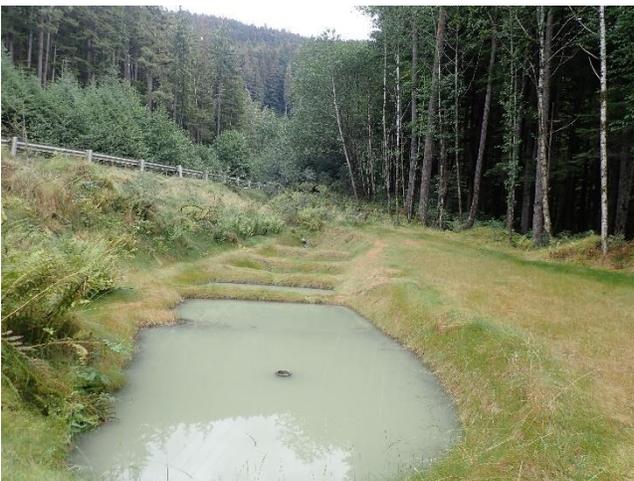
Photo 11. The BMPs for the Zinc Creek Bridge abutment.

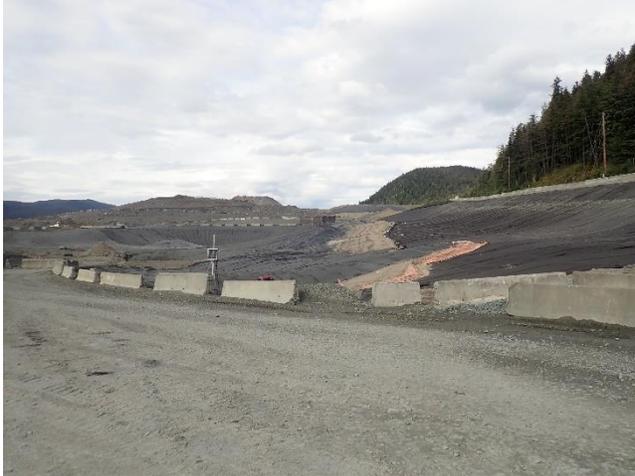
Surface Operations continue depositing tailings in the eastern section of the S3P1 expansion area (Photo 12). To help prevent fugitive dust over winter, HGCMC personnel recently applied hydroseed on tailings in the south-west section of the S3P1 area (Photo 13).

Photo 12. The eastern section of the S3P1 area.

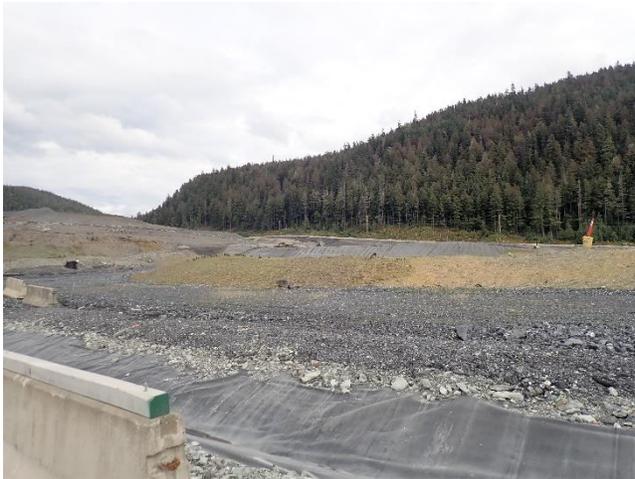
Photo 13. Hydroseed was applied to tailings in the south-west section of the S3P1 area.

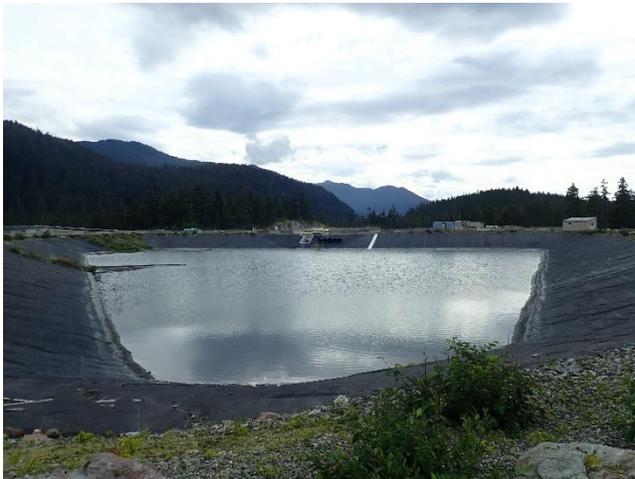
Photo 14. Pond 7.

Pond 7 (Photo 14) was collecting mine site water, and recirculated water from the TDF water treatment plant. Pond 10 (Photo 15) is collecting only direct precipitation.

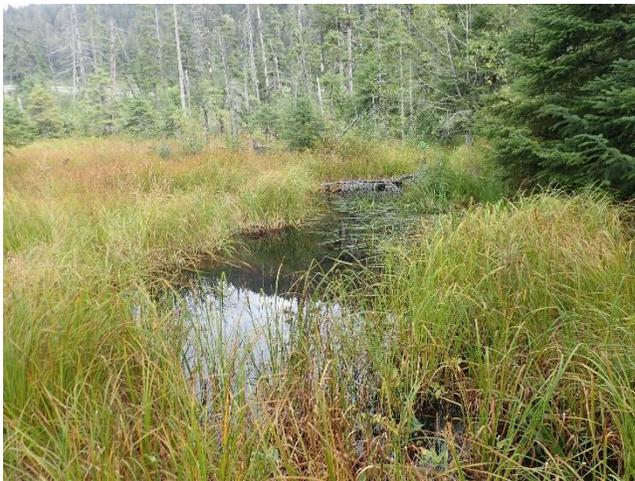
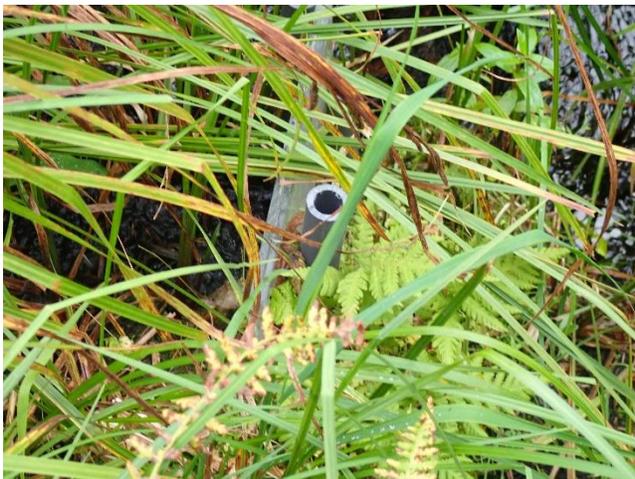
The water quality sampling site 1432 (Photos 16-17) was installed in 2011 by a consultant hired to conduct a hydrological investigation for the S3P1 tailings expansion area. Since 2015, HGCMC began sampling this site twice a year in the spring and fall to supplement data collected from FWMP site 9.

Photo 16. Wetland/ Headwaters for Tributary Creek.

Photo 17. Sampling well for site 1432.
